CALSPAN ON-SITE AIR BAG DEPLOYMENT INVESTIGATION

CALSPAN CASE NO. 91-14

FLEET - 1992 PLYMOUTH ACCLAIM

ACCIDENT DATE - [REDACTED] 1991

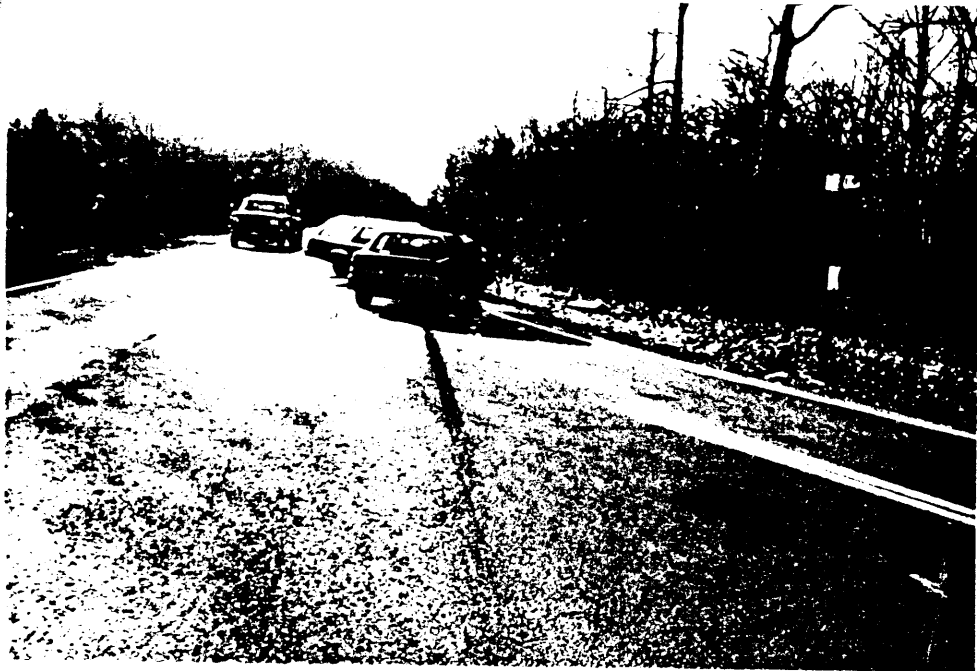
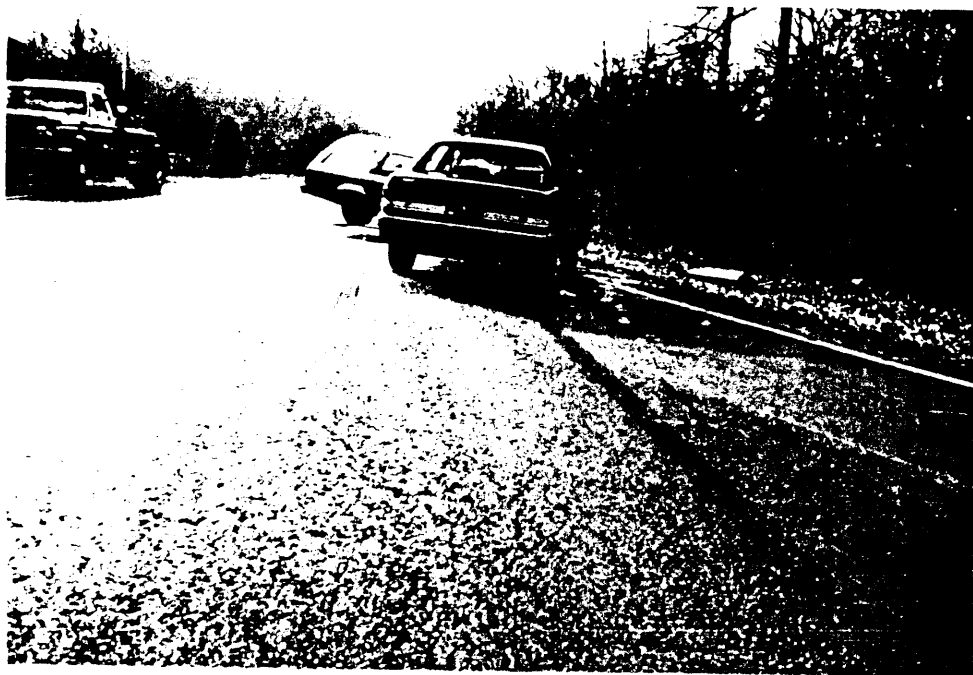
Pre-Impact Skidding Of The Plymouth And Final Rest Positions  
Of The Involved Vehicles.

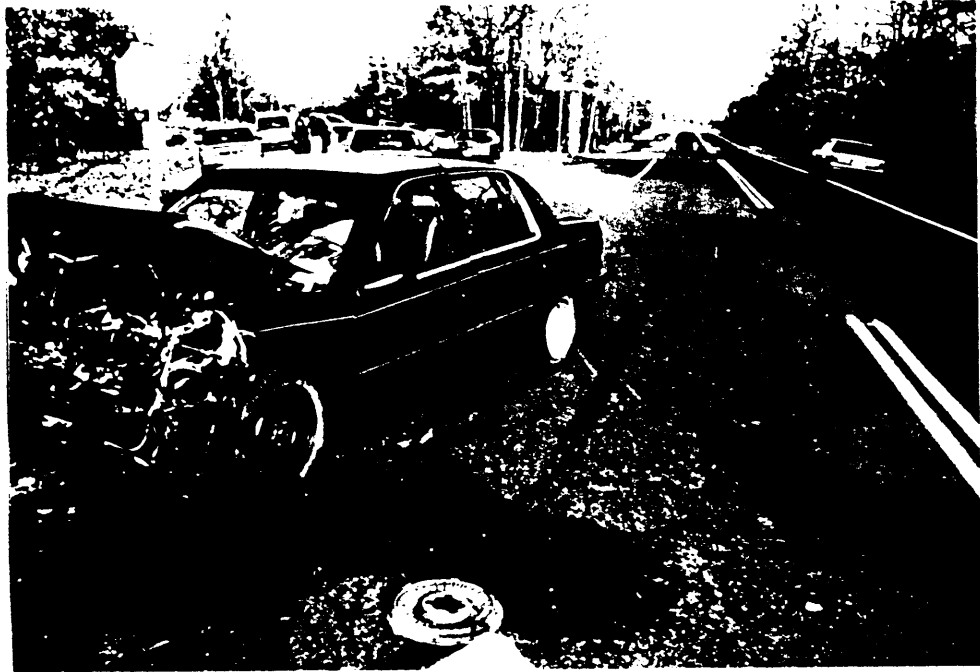
Lateral Displacement Of The Plymouth Acclaim.

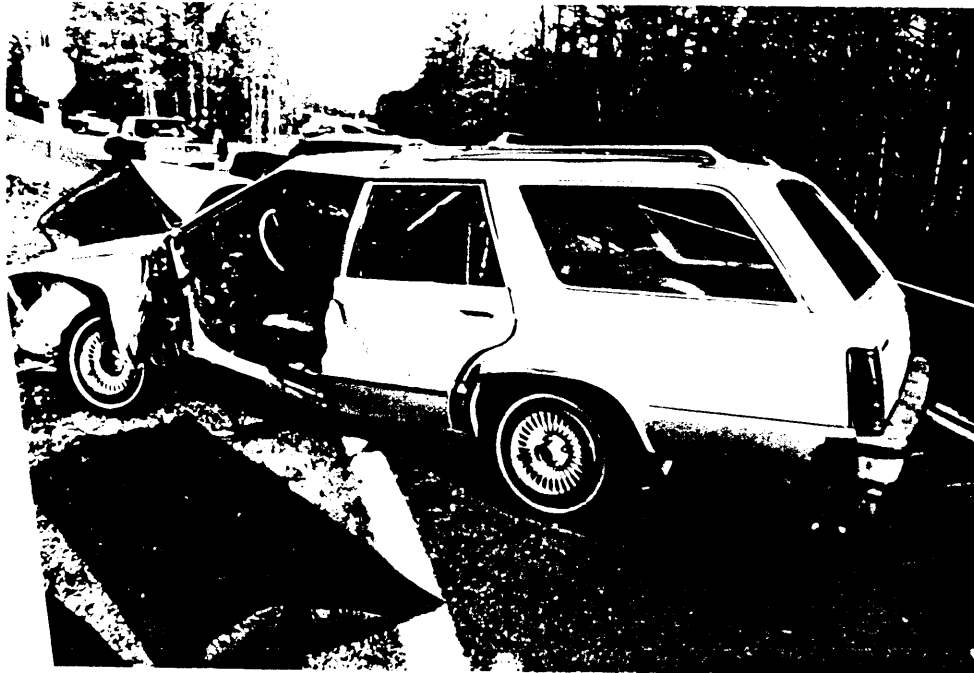
Impact Induced Displacement Of The Mercury Zephyr.

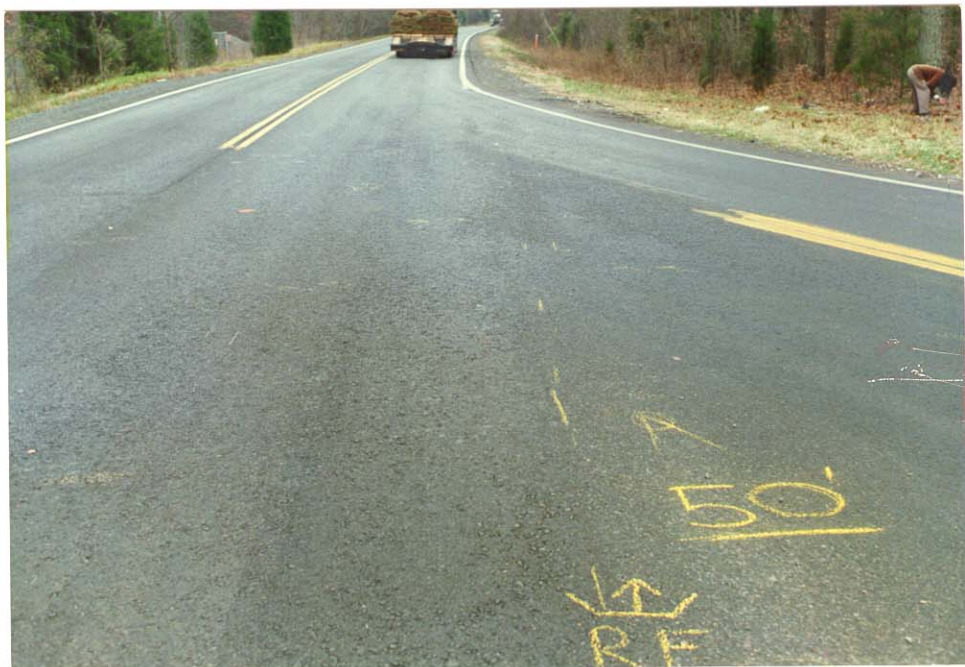
Beginning Of The Plymouth's Right Front Skid Mark.

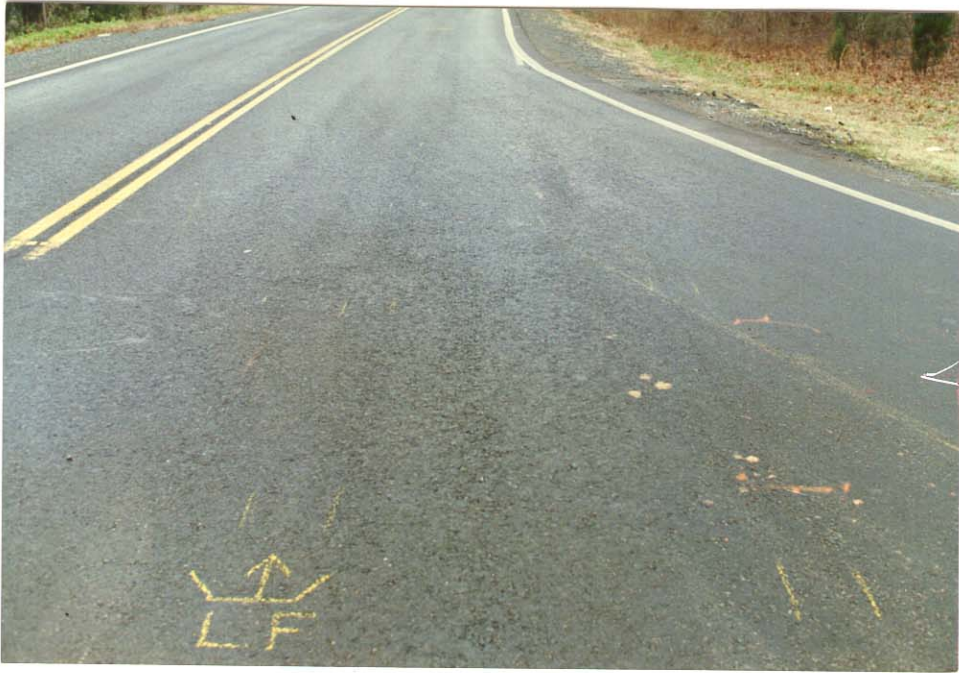
Beginning Of The Plymouth's Left Front Skid Mark As The Vehicle Skids  
In A Tracking Orientation To Impact.

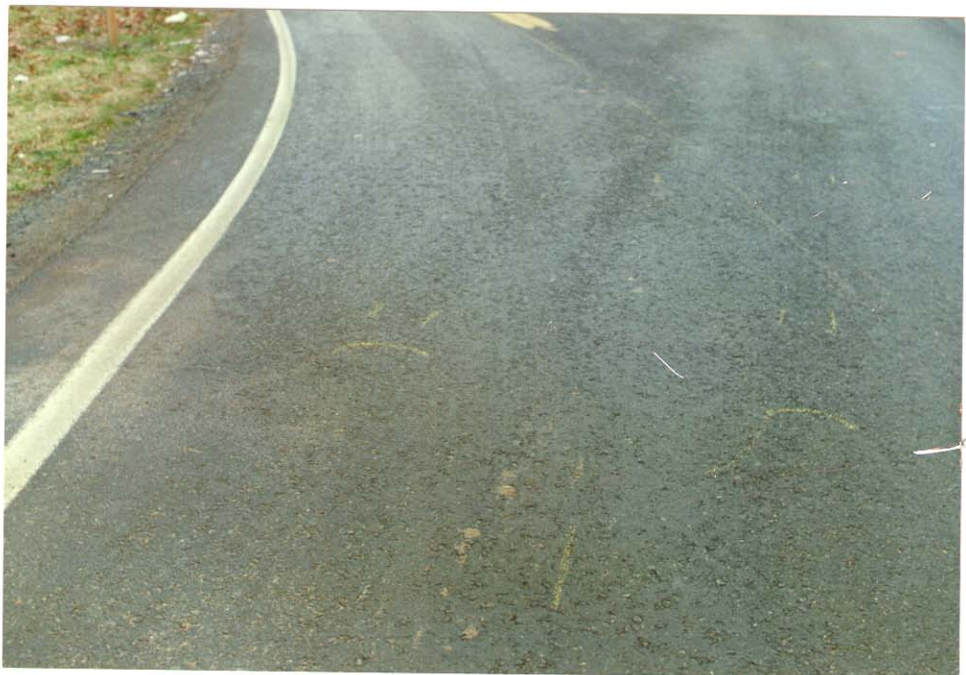
Point Of Impact, Deflection Of The Acclaim's Skid Marks.

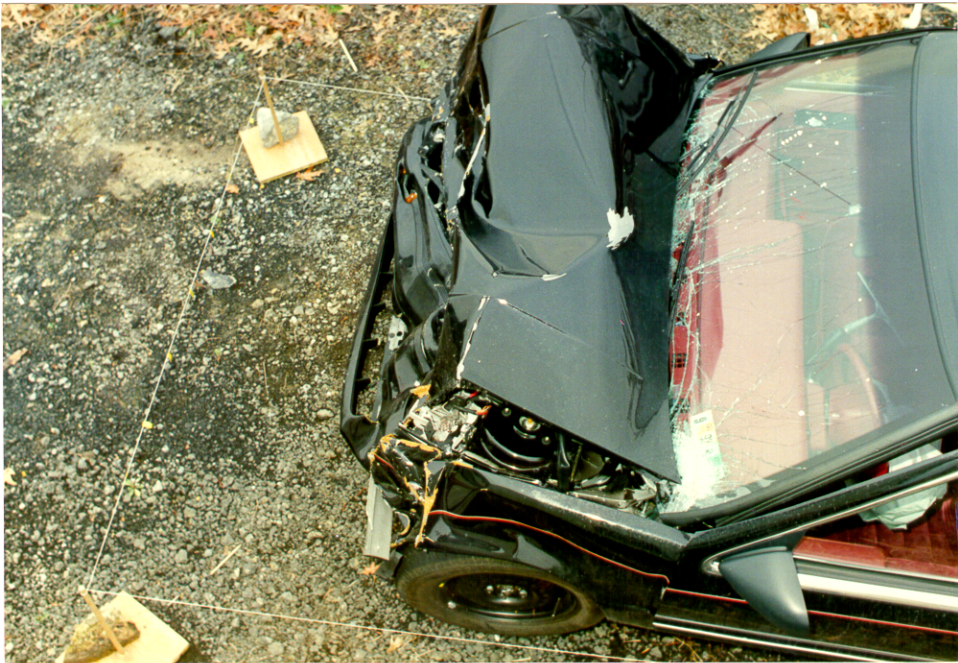
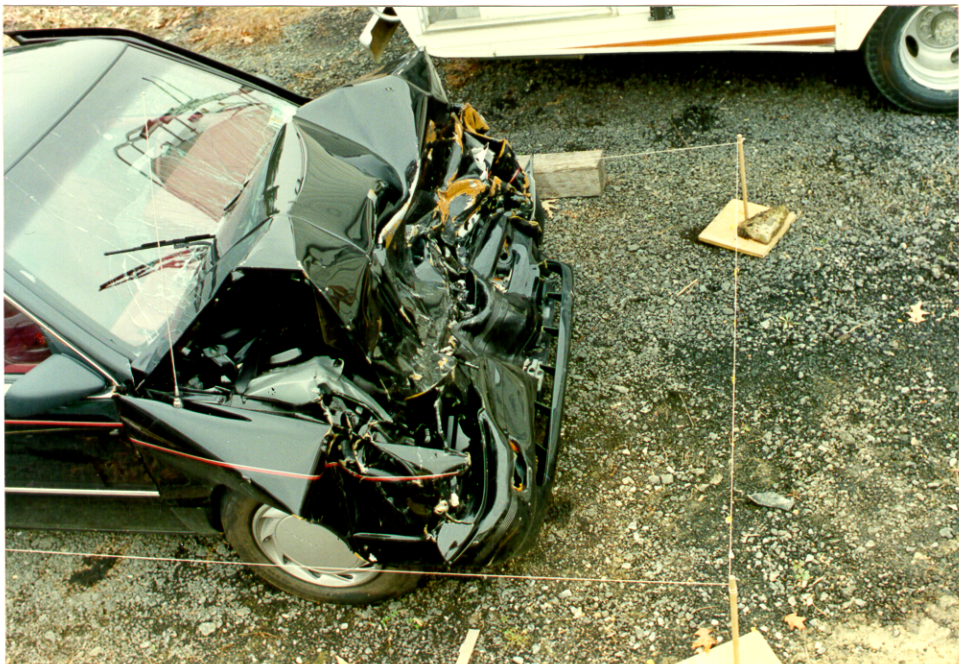
Overhead Views Showing The Extent of Frontal Crush.

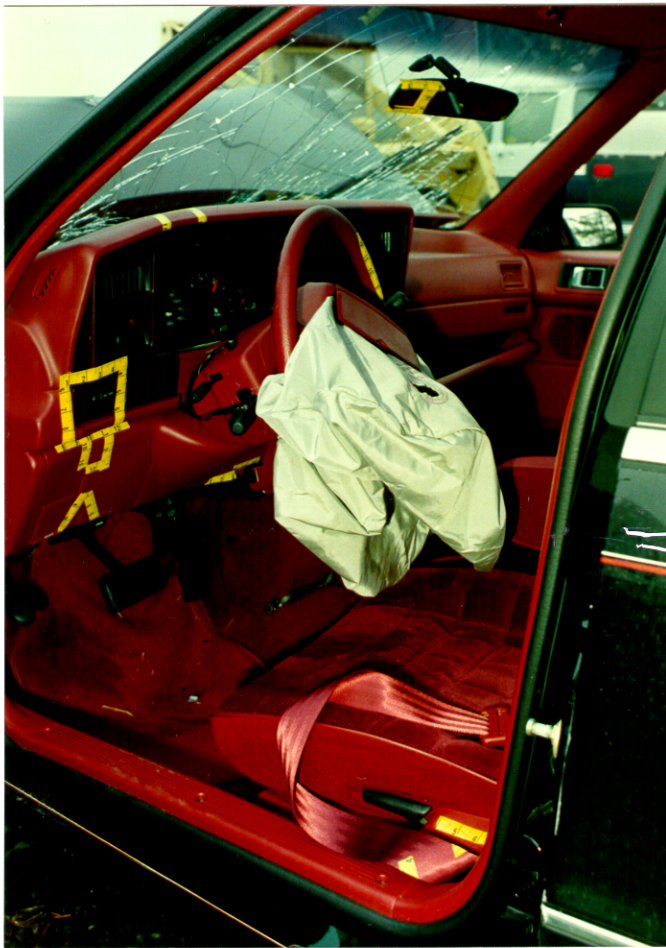
Overall Interior View Of The Deployed Air Bag And Occupant Contact Points.

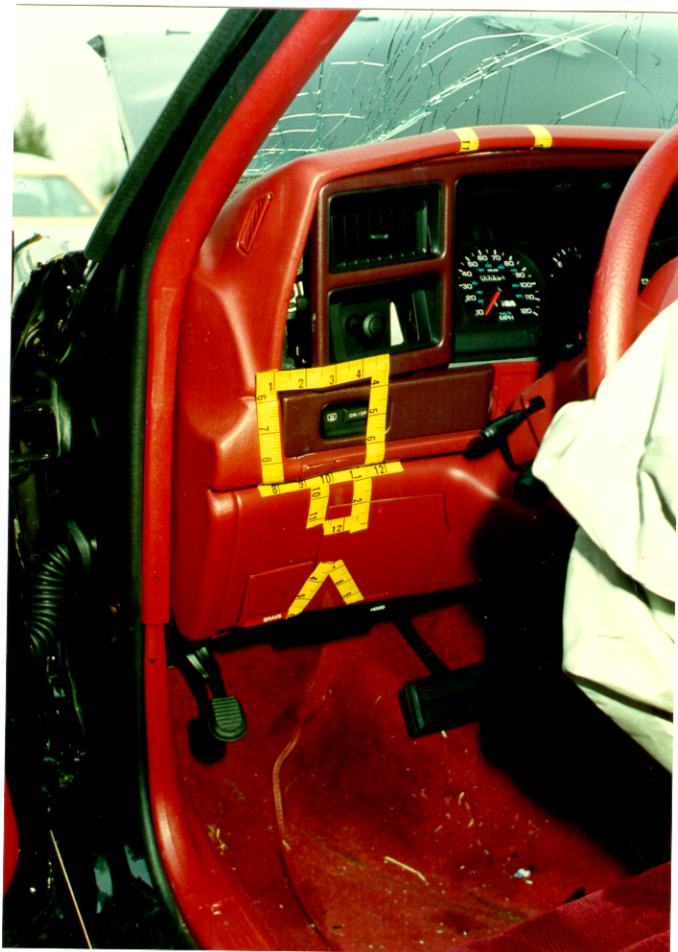
The driver's left knee impacted the left mid instrument panel adjacent to the backlight defroster switch. The contact cracked the plastic panel and deposited blue fabric transfers 20 - 23" left of center. As a result of the contact, he sustained a fractured left patella. The driver's lower left leg contacted the left side of the knee bolster at the fuse box cover. The contact produced blue fabric transfers on the struck component 20.5 - 21.5" left of center and abraded the driver's lower leg. His right knee impacted the knee bolster at the protrusion for the steering column and continued across the bolster into the center instrument panel adjacent to the radio. Abrasions and blue fabric transfers evidenced the contact sequence. As a result of the right knee loading, the driver sustained a ruptured tendon of the knee.

Driver's Left Knee And Leg Contacts To The Mid Instrument Panel and Knee Bolster.

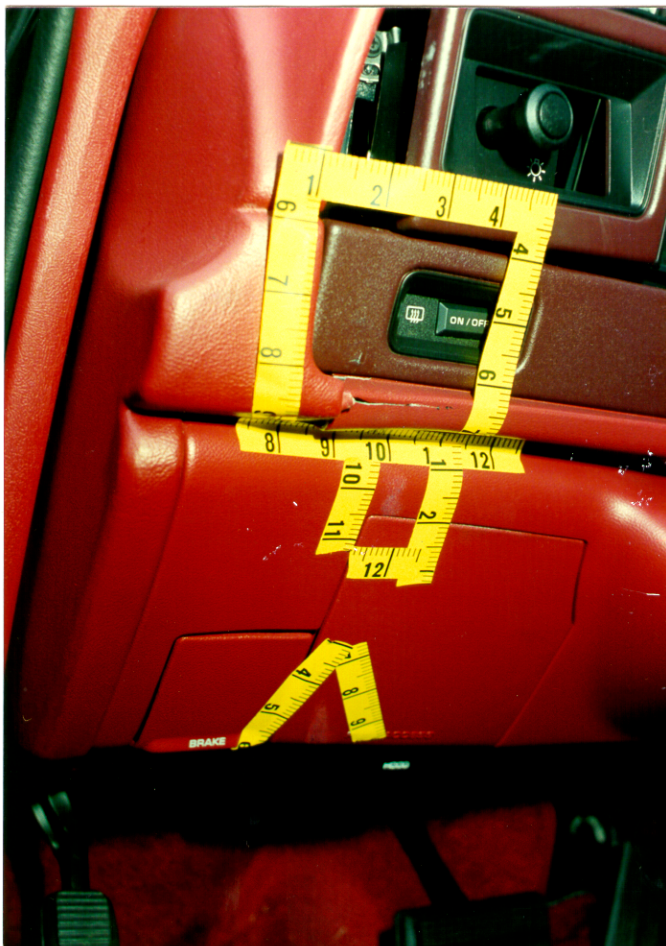
Closeup View Of The Driver's Knee And Leg Contacts.

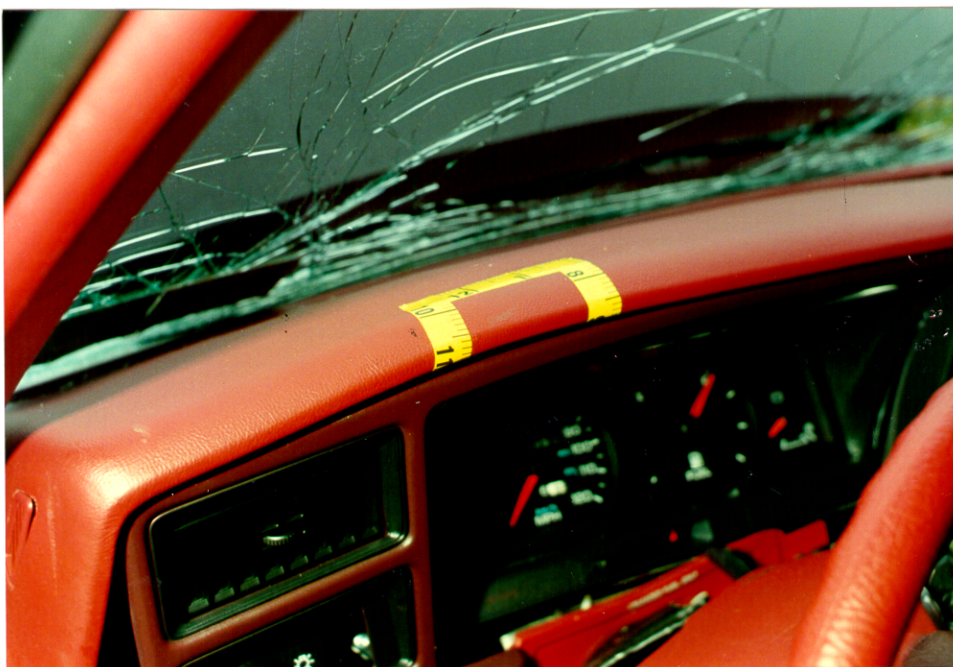
The driver attempted to brace against the steering wheel rim with both hands. His left hand separated from the wheel and impacted the upper instrument panel 16.5 - 18.5" left of center. The contact abraded the panel, compressed the energy absorbing material, and displaced the panel upward. As a result of the contact, the driver sustained a fractured left wrist. His right hand separated from the rim and probably impacted the center instrument panel area (no evidence of contact) which fractured his 4th and 5th metacarpals.

Driver's Left Hand Contact To The Upper Instrument Panel.

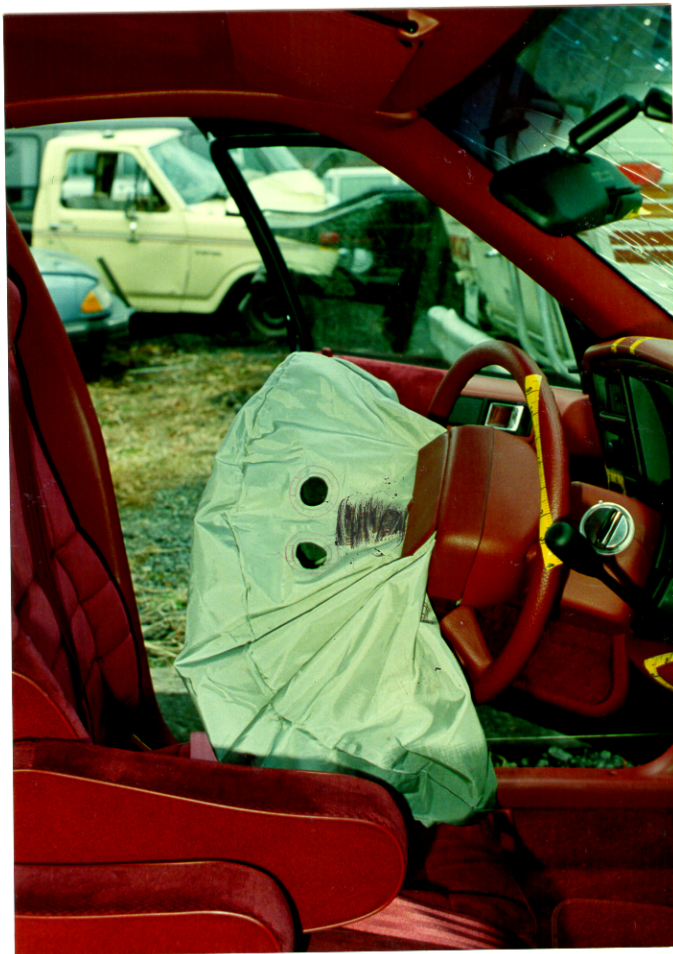
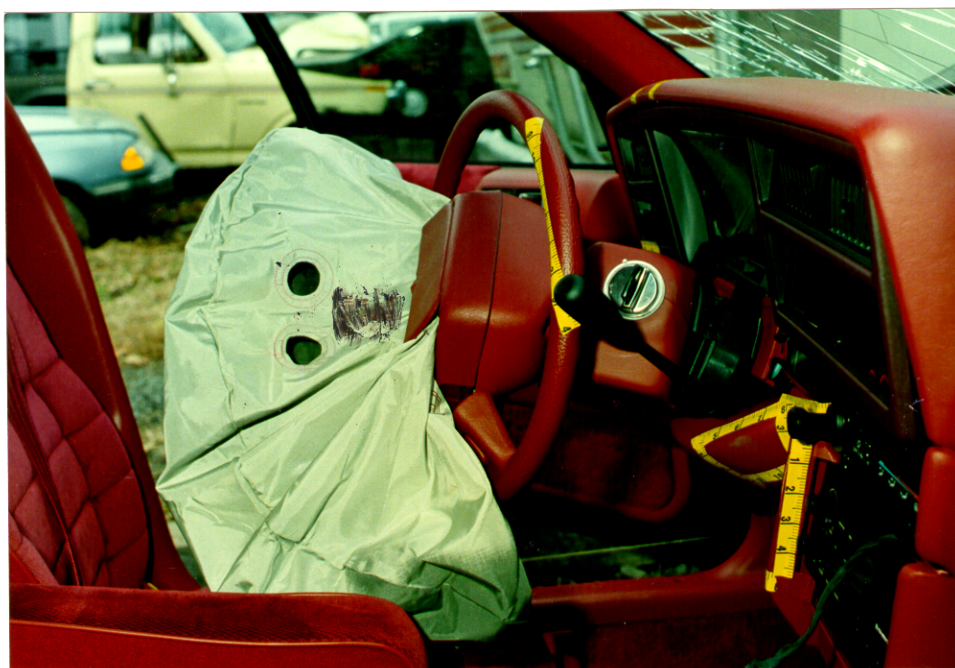
The driver's thoracic area subsequently loaded the deployed air bag with sufficient force to compress the bag against the steering wheel. His loading force was transmitted through the compressed air bag and into the steering assembly which resulted in bending of the steering wheel rim and compression of the energy absorbing steering column (2.5"). As a result of his loading against the active belt webbing and the air bag/steering assembly, the driver sustained four fractured ribs. He rebounded into the left front seat back where he came to rest.

Perpendicular Views Of The Steering Wheel Rim Deformation  
That Resulted From Driver Loading.

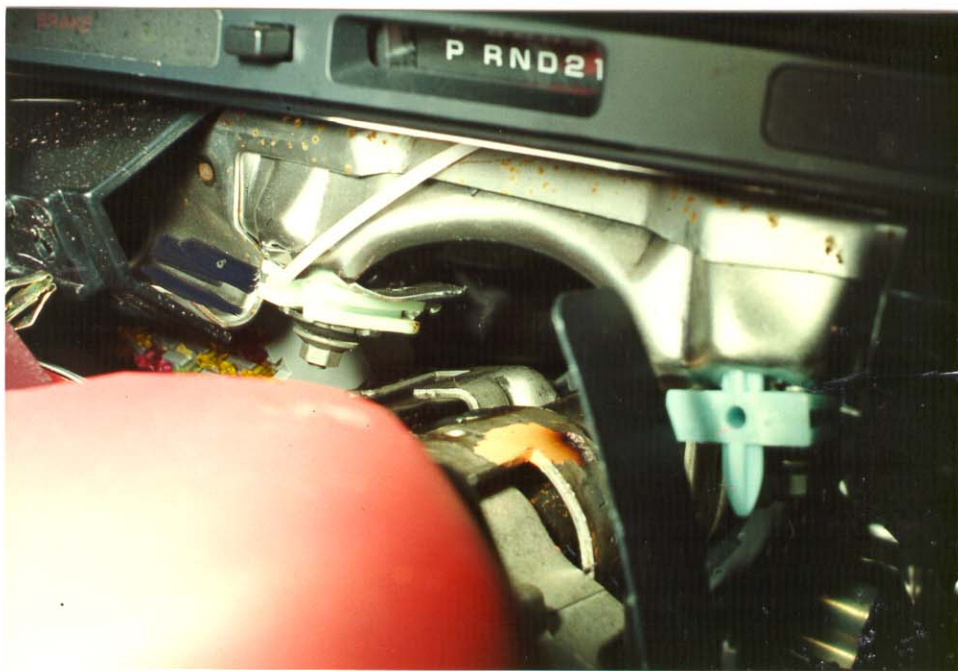
Left Shear Capsule Separation.

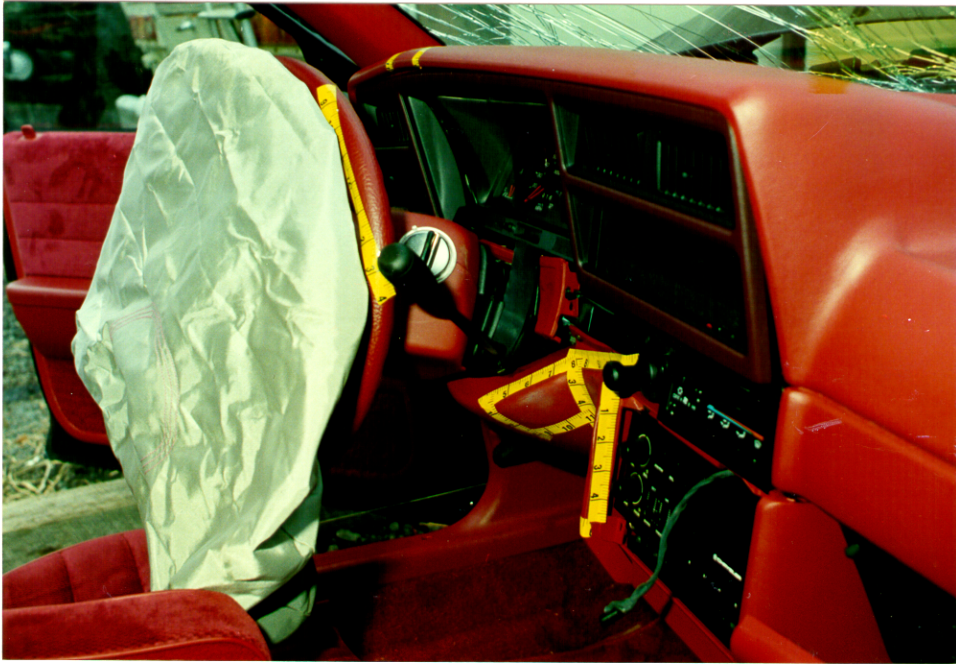
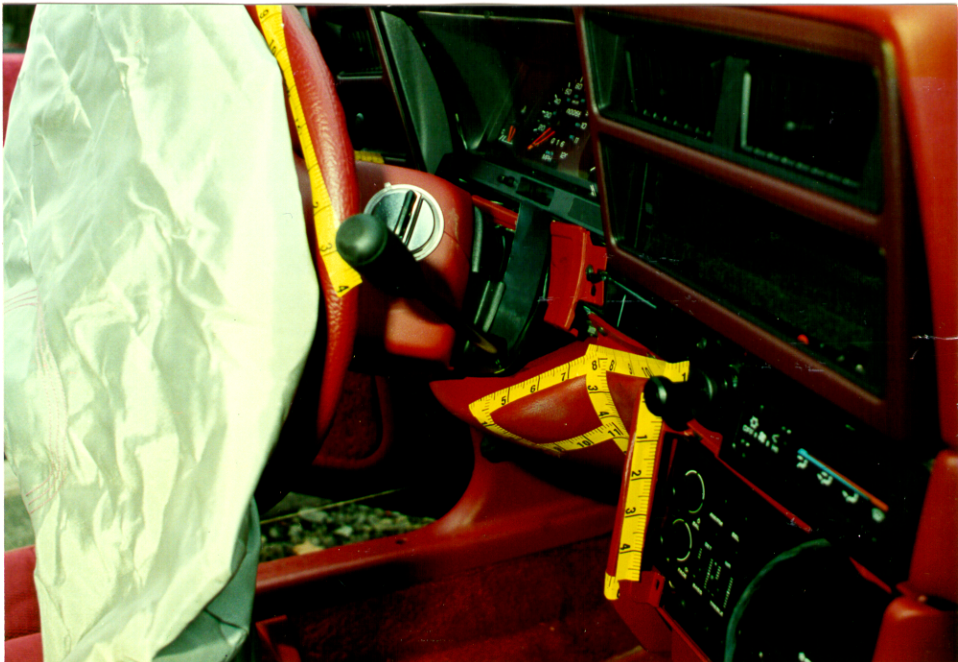
Driver's Right Knee And Leg Contact To The Knee Bolster.

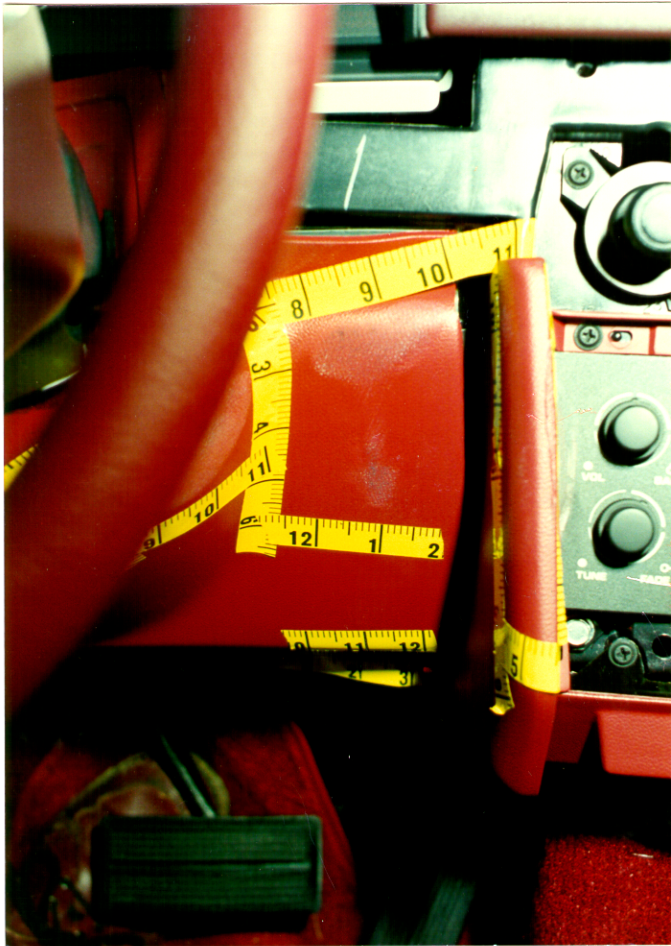
### Closeup View Of The Right Knee Contact

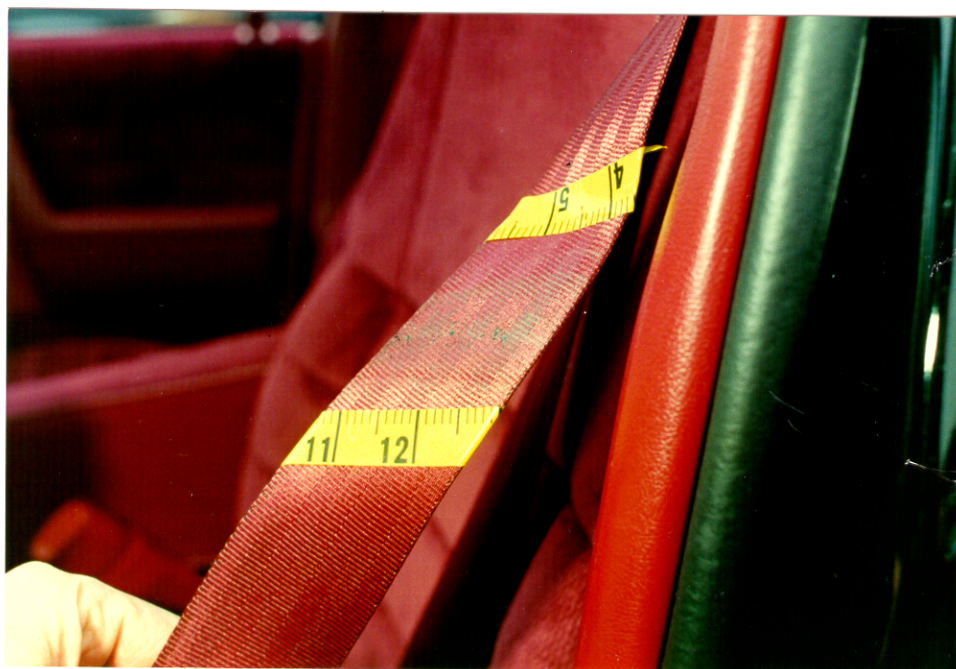
3" Diagonal D-Ring Transfer On The Shoulder Belt Webbing.

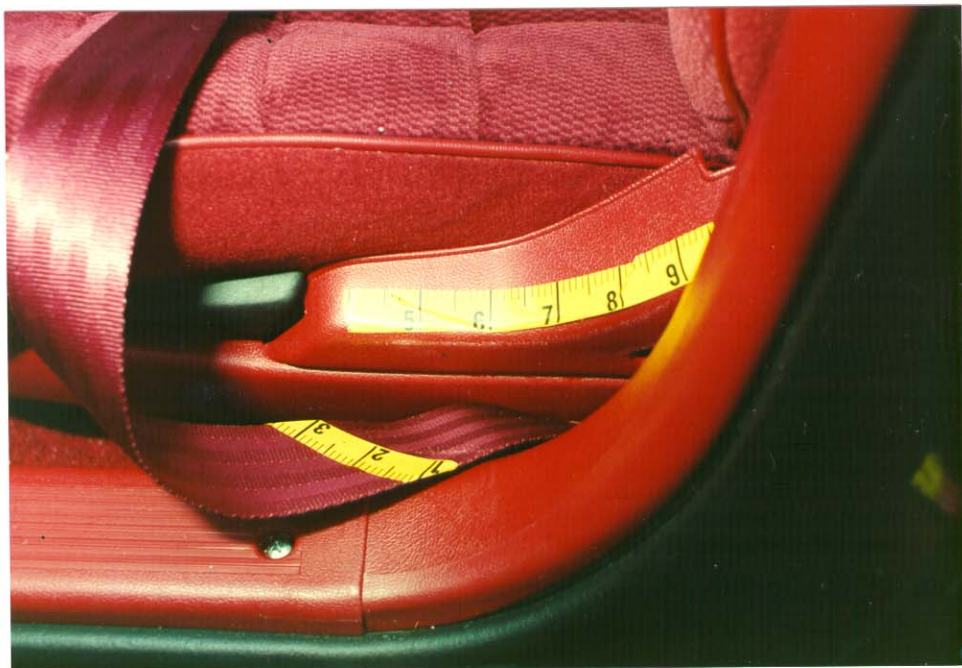
Lap Belt Loading Abrasions To The Plastic Extrusion  
At The Left Seatback/Seat Cushion Juncture.

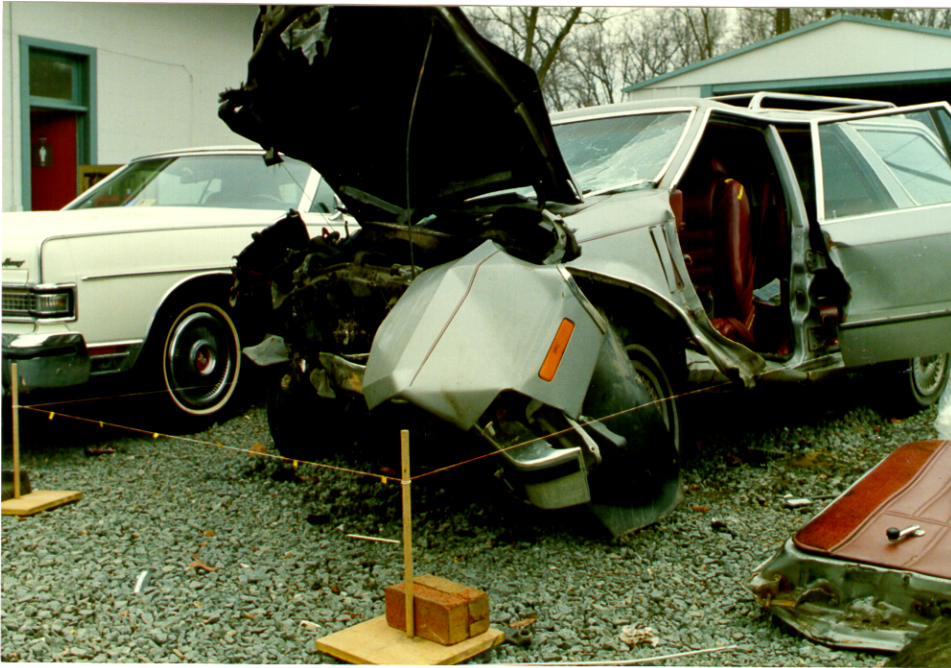
Left Front Three-Quarter View.

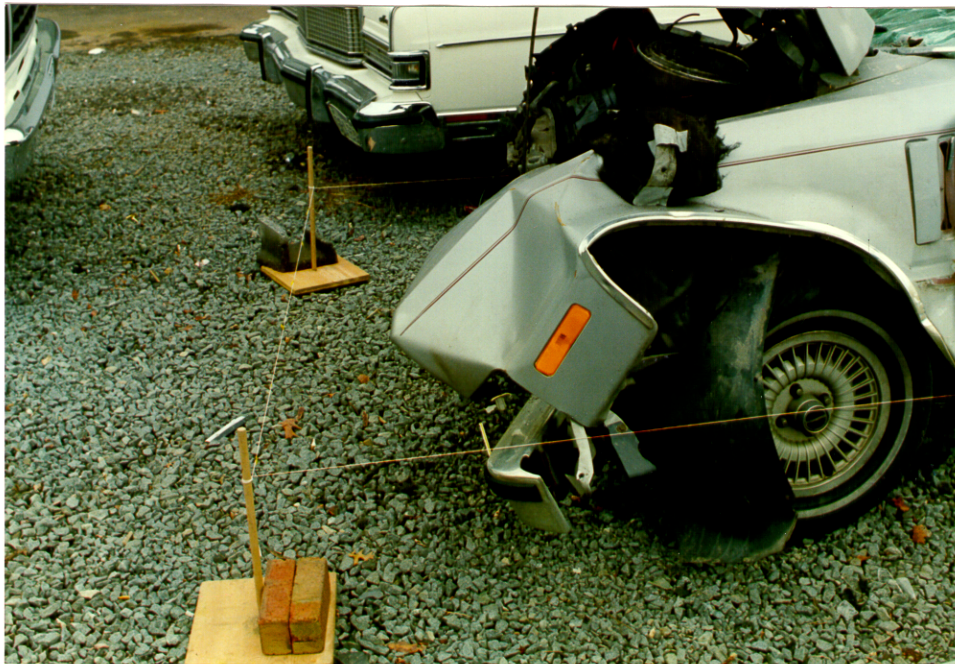
Perpendicular View Of The Left Frontal Area Showing The Extent Of Crush.

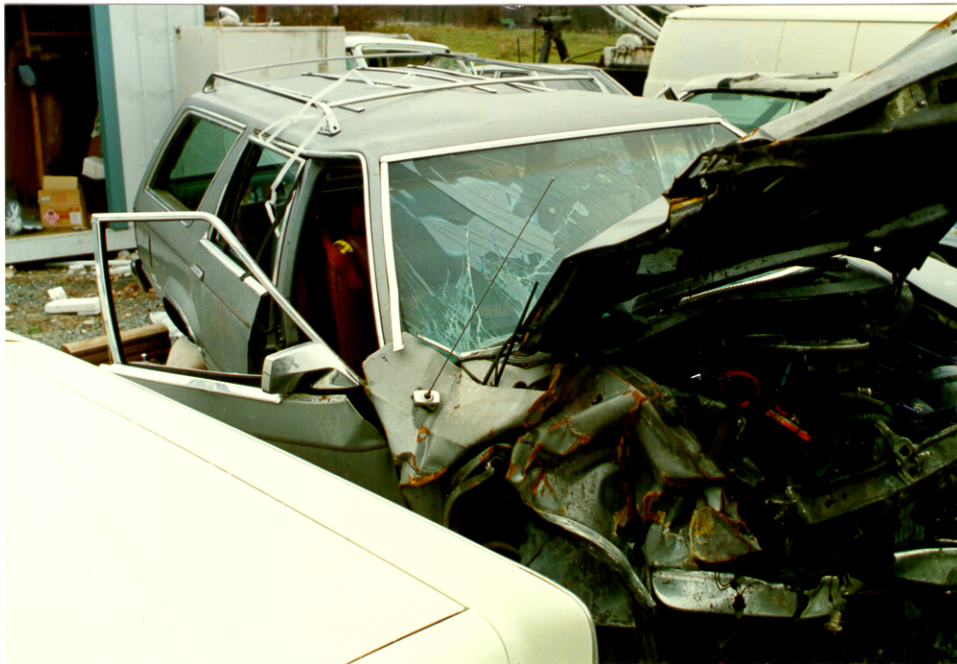
Right Side View Of The Mercury Zephyr.

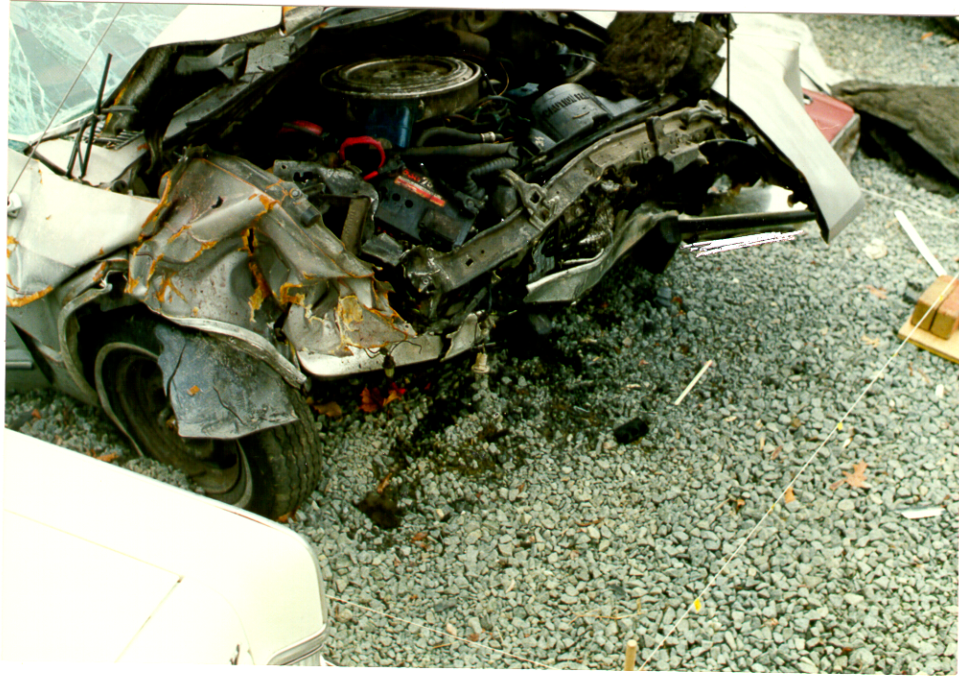
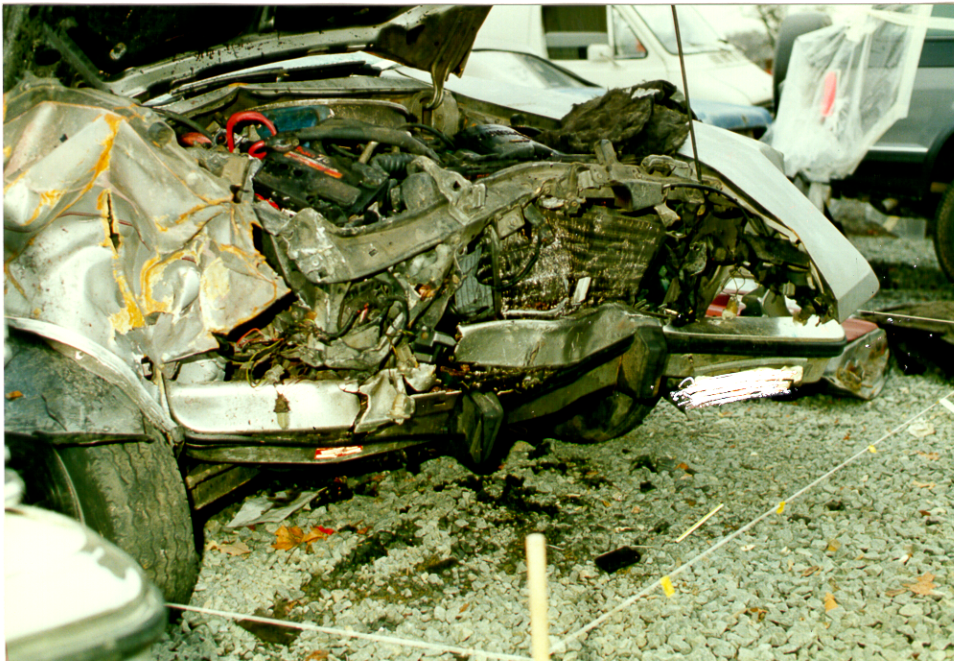
Closeup Views Of The Right Frontal Area Showing The Extent of Crush.

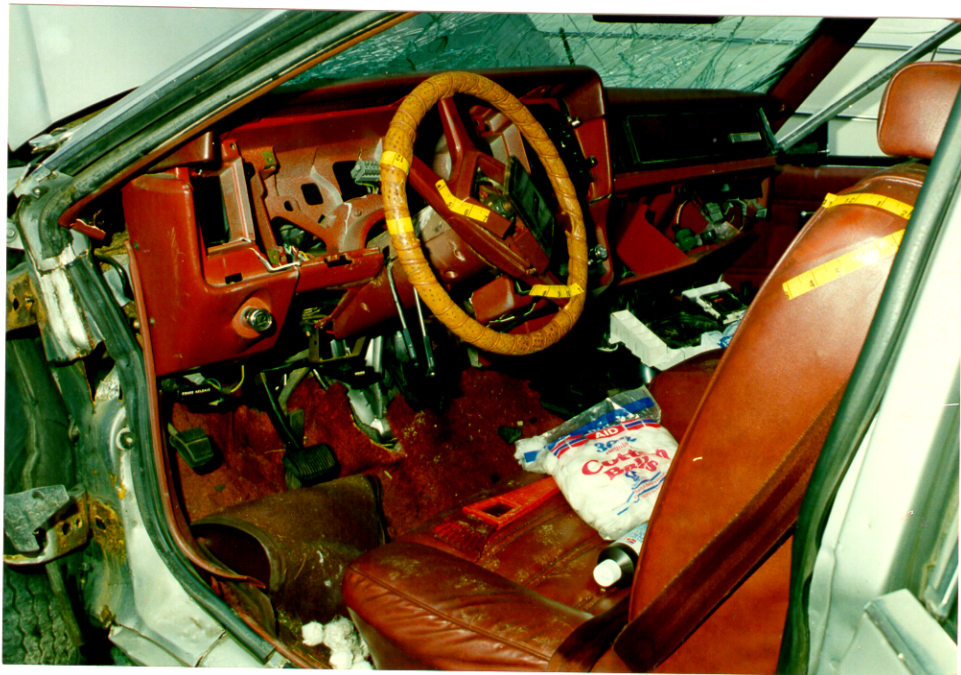
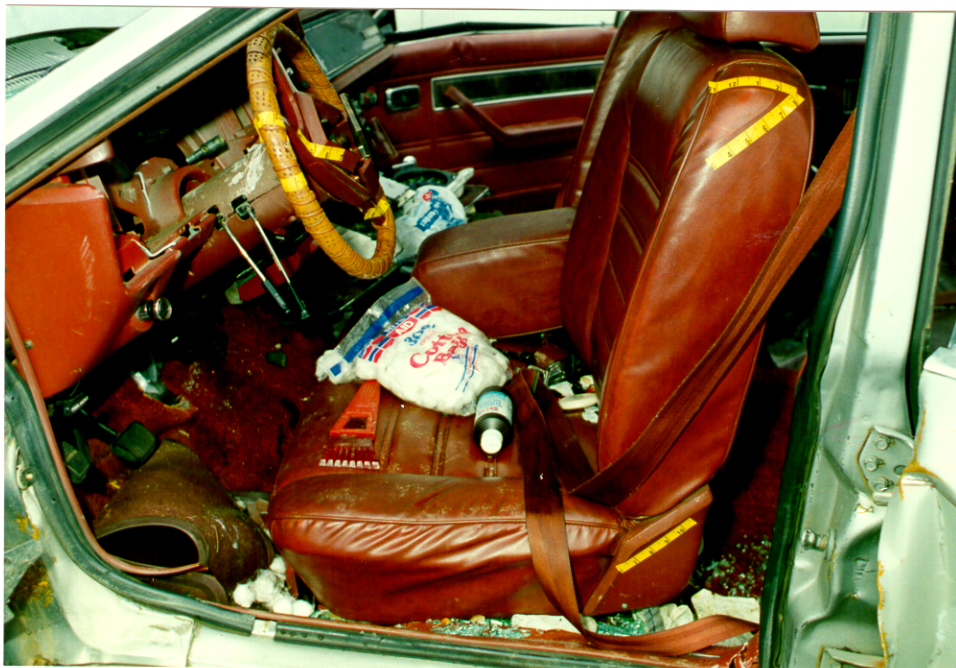
Overall Interior Views Of Driver #2's Trajectory And Contact.

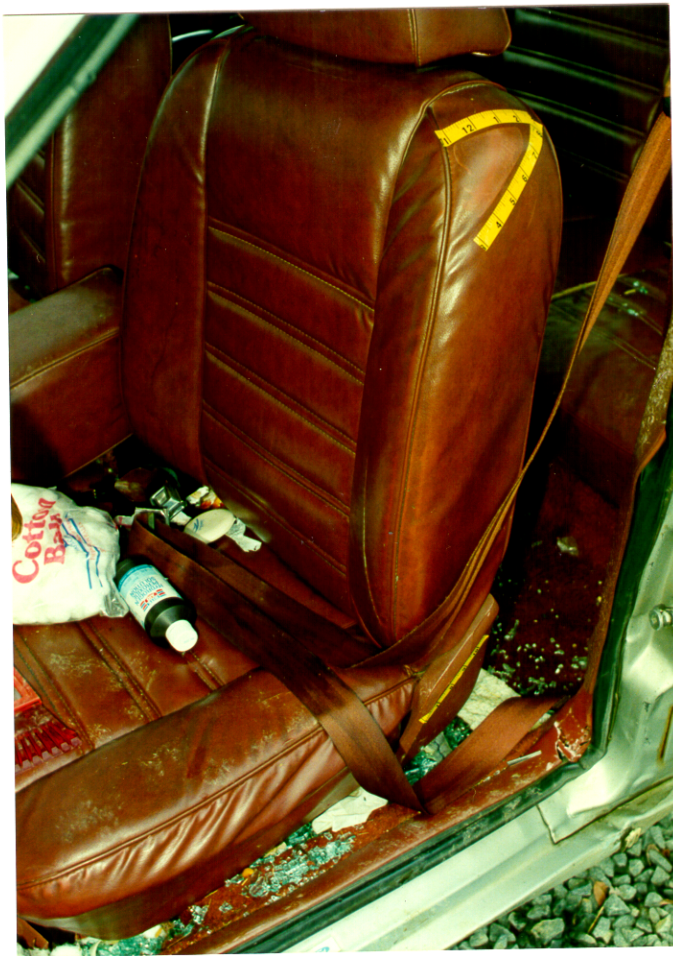
Driver's Seated Position And Active Belt System.

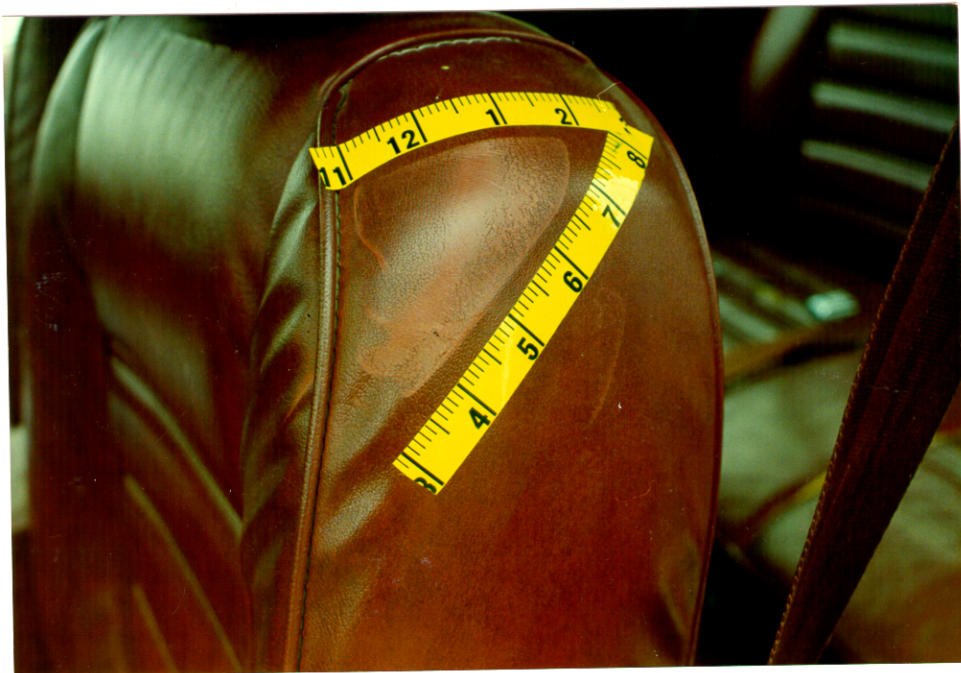
Shoulder Belt Abrasion To The Left Front Seatback.

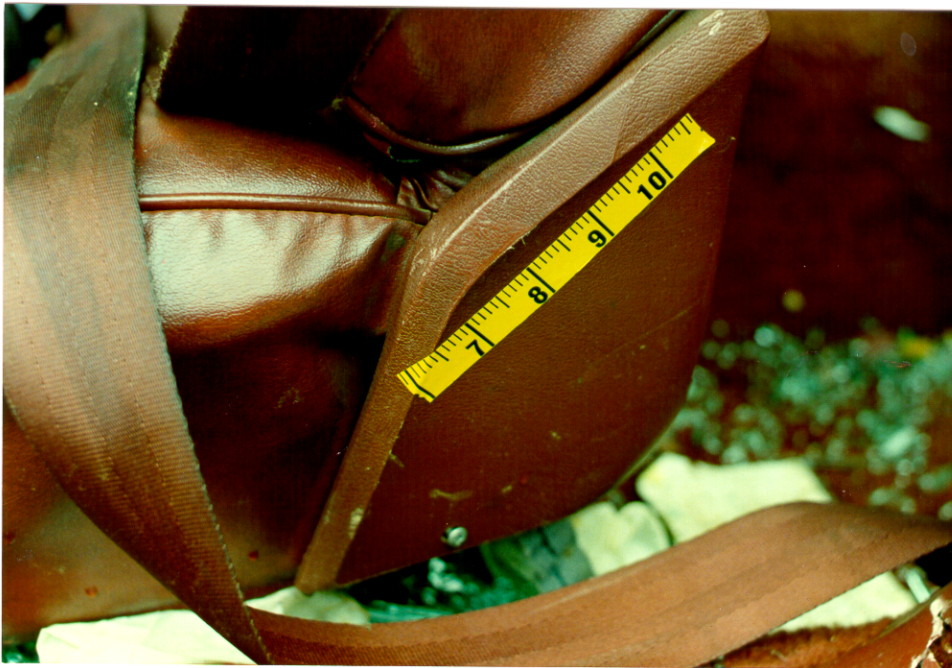
Lap Belt Abrasion To The Plastic Extrusion At The Seatback/Cushion Juncture.

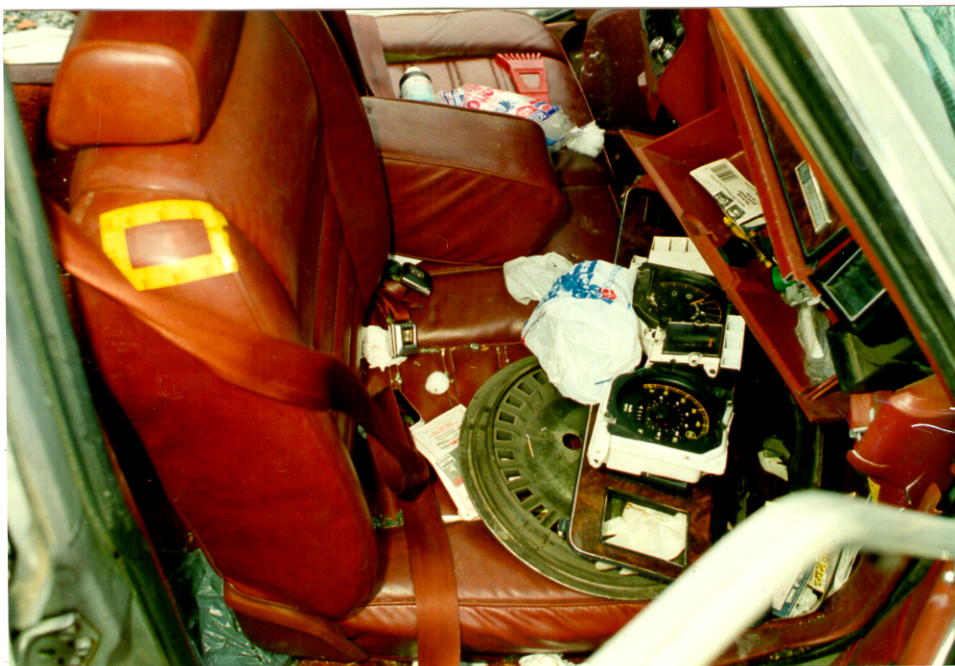
The right front passenger of vehicle #2 was restrained by the active 3-point lap and shoulder belt system. Based upon inspection of the belt webbing and the lack of head and/or thoracic contact points, the passenger was probably wearing the belt system correctly. At impact, she initiated a forward trajectory and loaded the belt webbing. Her loading force against the shoulder belt webbing abraded the right seat back at the apex of the side and top surfaces. The abraded vinyl was embedded into the belt webbing 45-47.5" above the floor anchor assembly. As a result of loading against the shoulder belt webbing, the passenger sustained fractured ribs and a ruptured spleen. The passenger's right knee contacted and

Right Front Passenger's Active Belt Webbing And Belt Abrasion  
To The Right Upper Seatback.

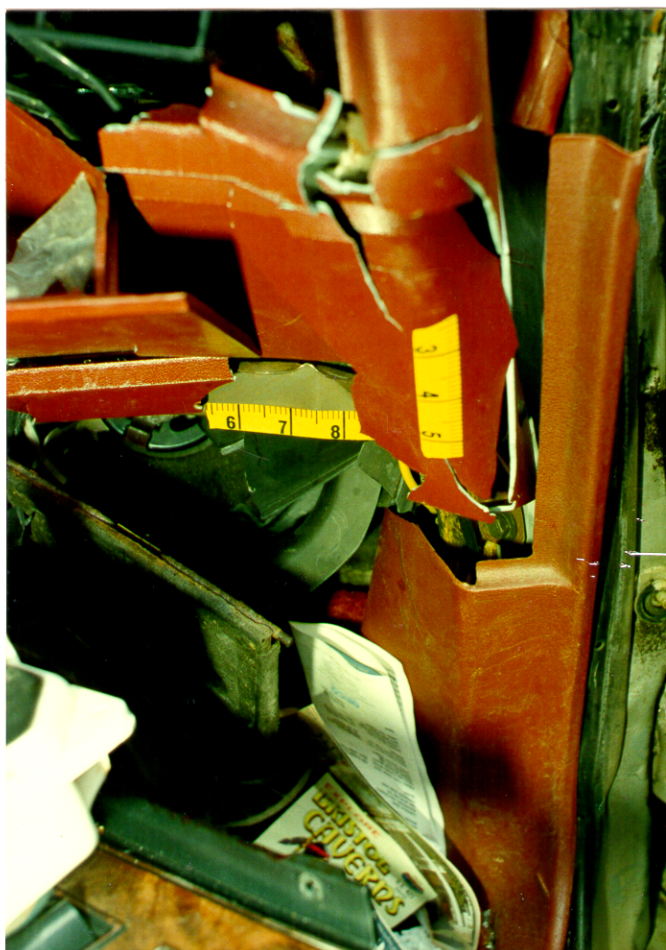
Right Front Passenger's Right Knee Contact To The Glove Box Area.

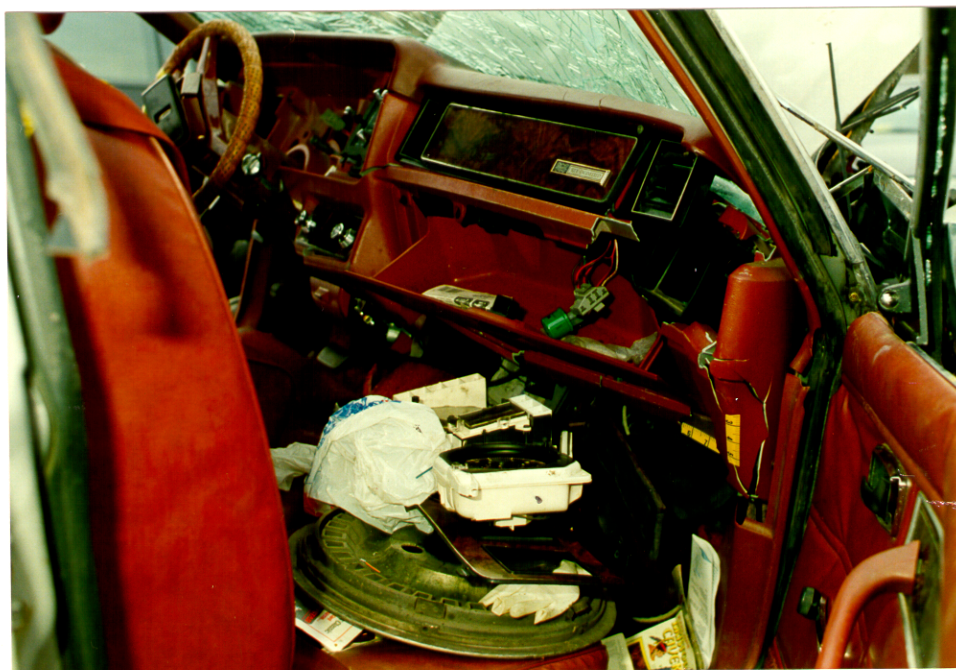
Overall View Of The Right Front Occupant's Position and Contact Points.
